# External strengthening of unreinforced masonry walls with polymers reinforced with carbon fiber

Camilo Vega<sup>1</sup>, Nancy Torres<sup>2</sup>

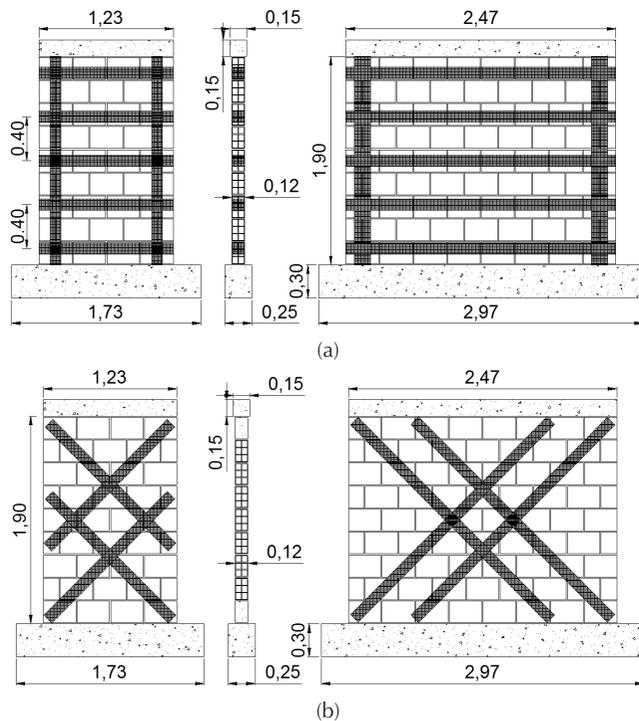
**Figure 2.** Dimensions (m) and reinforcement: (a) Slender and squat grid-walls; (b) Slender and squat diagonal-walls.

FRP systems are usually installed to increase the strength of URM walls. The basic wall strengthening scheme encompassed: 1) the Carbon Fiber Reinforced Polymer (CFRP) strengthening of the masonry walls to resist stresses due to the in-plane loads, and 2) the anchorage of the wall to the concrete beams, to provide a load path for the in-plane loads, so that the strengthened wall could function effectively as a lateral-load resisting element. The wall specimens were strengthened with CFRP strips, which were installed using the manual lay-up technique. This reinforcement was fitted on just one face of the wall and anchored on its opposite side. There were two reinforcement layouts: grid and diagonal. The grid layout involved the installation of five horizontal CFRP strips of 0,10 m wide, spaced every 0,40 m; and two vertical ones at each end of the wall, of 0,10 m wide for slender walls, and 0,15 m for squat walls (Fig.2a). The diagonal layout involved the installation of four diagonal CFRP strips of 0,10 m wide, oriented at approximately 45° degrees to the horizontal side (Fig. 2b). The designs of the FRP reinforcements for the sample specimens were based on the guidelines established in the ACI 440.7R-10 document. The design philosophy is based on limit state design principles.

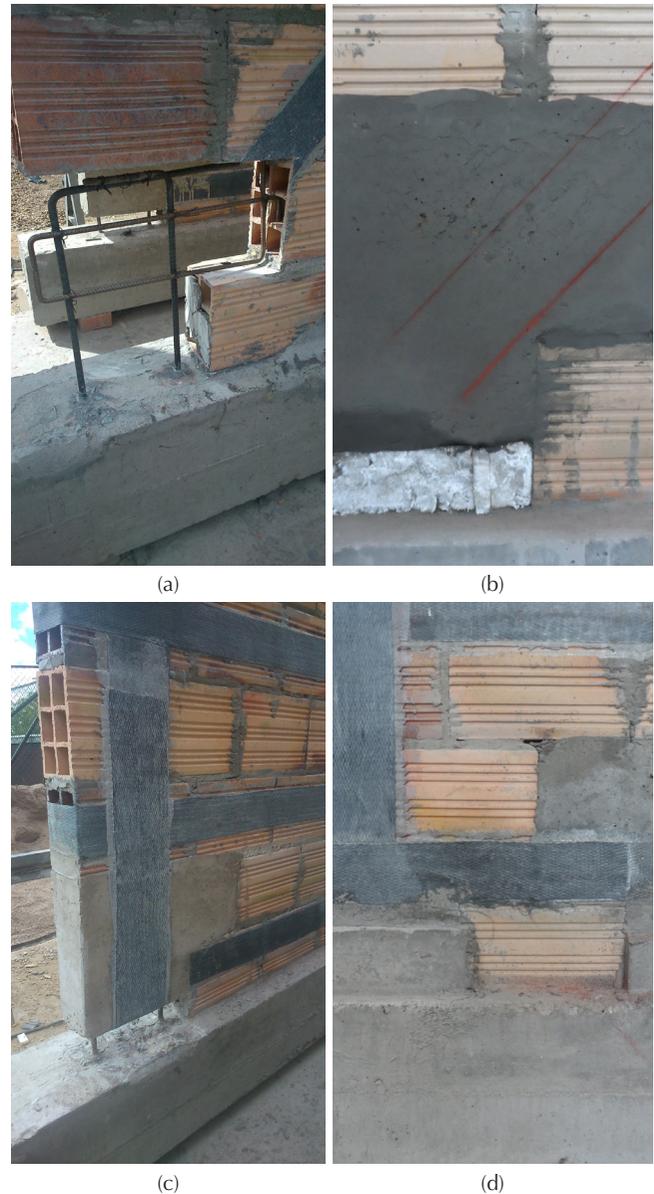
**Figure 3.** Construction process of the anchorage system: (a) removed masonry units and hooked steel bars; (b) placed grout block with bottom gap; (c) installed FRP strip wrapped around grout block; and (d) additional grout filling the gap.

In order to completely connect the wall to its foundation, guaranteeing its behavior as a shear wall, the anchorage system for the strengthened walls involved the removal of selected masonry units at the edges of their bottom row. From each edge, one unit and two and a half units were removed in the slender and squat walls, respectively. As replacement of these units, concrete blocks were built. Two #4 diameter epoxy-anchor hooked steel bars were embedded 150 mm into the base beam for building a repair grout solid block. This procedure was done in two phases, leaving a gap at the bottom for wrapping the CFRP strip around the grout block and through the gap. Before wrapping the polymer, the corners of the grout blocks were rounded to a 50 mm radius. Finally, the gap was filled with an additional grout. Figure 3 shows the installation of the anchorage system for the squat walls. This anchor system was employed for strengthened specimens only. The horizontal strips were anchored on the opposite side of the wall.

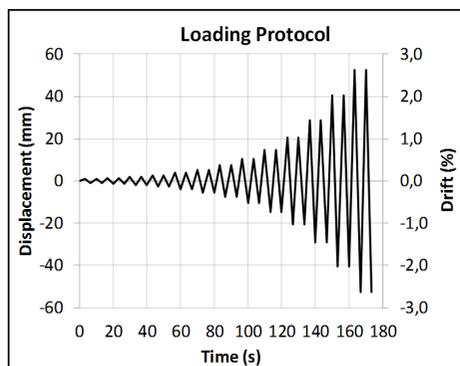
Figure 4. Loading protocol.  
Source: Authors

- **Monotonic loading:** The primary objective of this phase was to evaluate the anchorage system. This phase involved testing of four walls under monotonic in-plane loads, including two unreinforced masonry walls used as control specimens. The monotonic in-plane load was applied at a load rate of 0,22 kN/s, until reaching failure of the anchorage system.
- **Cyclic loading:** The objective of this series was the evaluation of the two strengthening layouts working in conjunction with the anchorage system. This series involved the testing of four walls under in-plane cyclic lateral load, following a displacement-controlled method as specified by the FEMA 461. The loading sequence consisted in repeated cycles of step-wise increasing deformation amplitudes. Two cycles for each amplitude were done. Figure 4 shows the loading protocol. The cyclic load was applied at a frequency of 0,15 Hz.

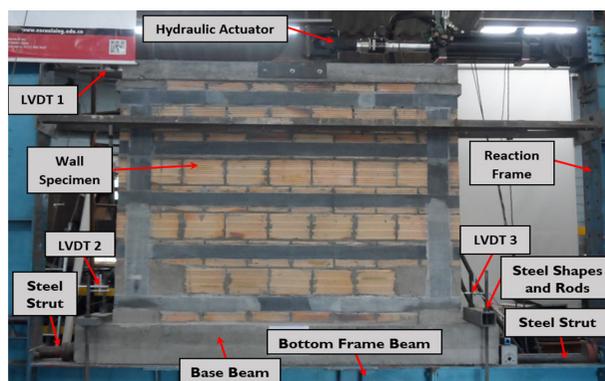
Figure 5. Overall view of the test setup.  
Source: Authors

The walls were tested at the Structural Laboratory of the Escuela Colombiana de Ingeniería Julio Garavito in Bogotá, Colombia. The walls were tested within a steel structure used as reaction frame. The reaction frame is a permanent steel structure anchored to the structural floor of the laboratory and designed to resist in-plane loads of up to 300 kN. The reaction frame consists of two built-up steel columns in the sides and two built-up steel beams in the top and bottom. For monotonic tests, the in-plane loads were generated by a hydraulic jack that had a capacity of 250 kN. During the test, the force was measured with a load cell of 50 kN of capacity, and sensitivity of 10 N. For the cyclic tests, in-plane loads were generated by a pseudo-dynamic hydraulic actuator mounted on a column of the reaction frame and connected to the top of the test wall.

and high-strength steel rods. To prevent sliding, structural steel struts were installed between the beam ends of the concrete base and the frame columns. The test configuration without load applied at the top of the wall provides the most adverse condition for the anchorage at the wall base. Besides, walls built with blocks of clay with horizontal perforations are commonly used in one- or two-story buildings, where the axial load is low. Three Linear Variable Differential Transducers (LVDTs) were used to monitor the wall displacements at the top and bottom.

Figure 5 shows an overall view of the test setup and illustrates the location of the instrumentation. The loading process was suspended once the failure of the wall was reached, which corresponds to a drift of 2,5%.

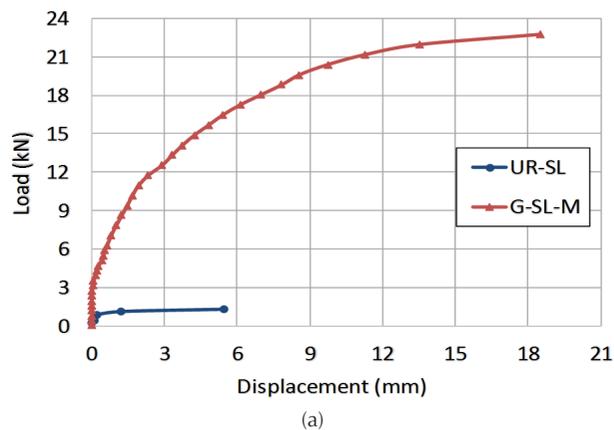
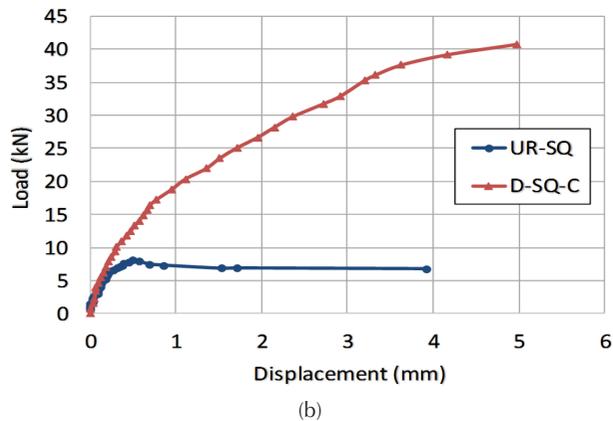
**Figure 6.** Load vs. Lateral Displacement: (a) Slender walls; (b) Squat walls.  
Source: Authors

Table 3 presents the maximum load that each wall resisted in the monotonic tests, while Figure 6 presents the load resisted versus the lateral displacement registered.

In the squat wall with diagonal reinforcement, there is a significant increase in the resistance to lateral loads. This wall reached resistances 5 times greater than those of unreinforced walls. Regarding the slender wall with grid reinforcement, performance is even greater, as it achieved resistance 18 times greater than the one of the unreinforced wall.

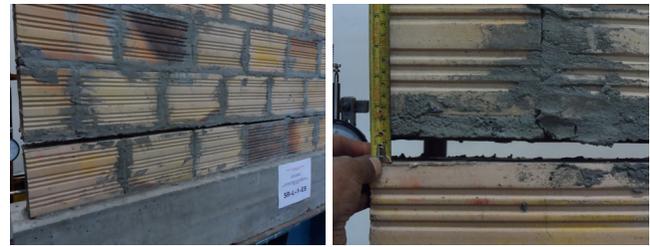
**Figure 7.** Failure mode of the URM walls.  
Source: Authors

The test results of the control walls showed that the flexural failure occurred at the base of the walls. This type of failure was expected given that the walls were essentially cantilever elements. In cantilever masonry walls, such as those tested in this research, the initial crack typically appears at the base of the tested wall. Failure modes of the two URM control walls (UR-SL and UR-SQ) initiated with a single flexural horizontal crack along the mortar joint above the first row of masonry units (Fig.7). No toe crushing or diagonal cracking was evidenced. The flexural failure occurred at loads of 1,3 kN and 8,2 kN for UR-SL and UR-SQ, respectively.

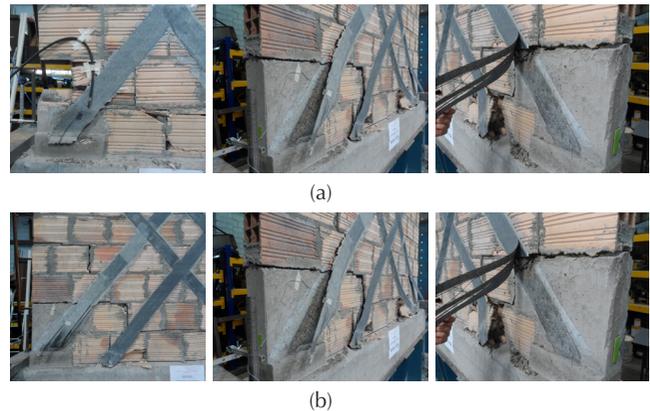
**Figure 8.** Failure mode of the diagonally reinforced walls: (a) Slender walls; (b) Squat walls.  
Source: Authors

Diagonally reinforced walls failed due to the rupture of the CFRP wrapped around the grout block at the base. Moreover, debonding and delamination of the reinforcement from the wall was observed, which generated tensile-related failures and breaking of some masonry units (Fig.8a). Although the squat specimens showed a principal staircase-shaped crack, it initiated at the medium part of the wall and extended to its base (Fig.8b). Once again, the rupture of the fiber in the anchoring region indicates that the main failure was flexural.

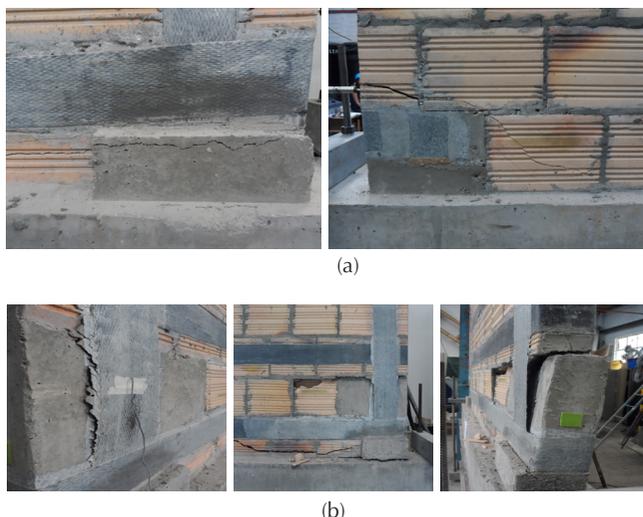
**Figure 9.** Failure mode of the grid reinforced walls: (a) Slender walls; (b) Squat walls.  
**Source:** Authors

Grid-reinforced specimens presented flexural failure as well. The breaking of masonry units along the principal cracks was very common, due to the compressive stress. These cracks were located within the first row of mortar, and between the wall and the concrete blocks. This failure generated wall displacement, relative to one of the anchoring blocks. This was observed in the squat specimen, which decreased its loading capacity (Fig.9b). Otherwise, in the slender wall, a failure was produced at the joint of the grout from the anchoring system, while a series of tensile related fissures appeared in some units at the base of the wall (Fig.9a). Due to this behavior, the CFRP could not work at its maximum capacity, and only showed a small failure related to adherence in the grout block region (Fig.9b).

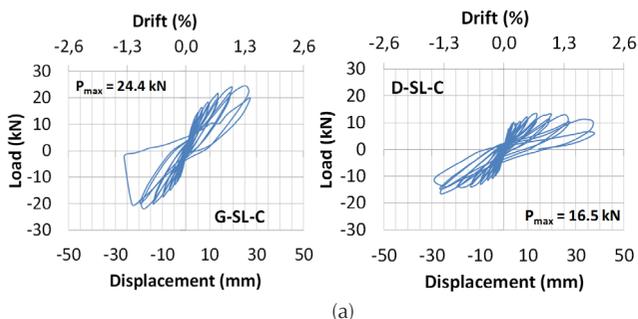
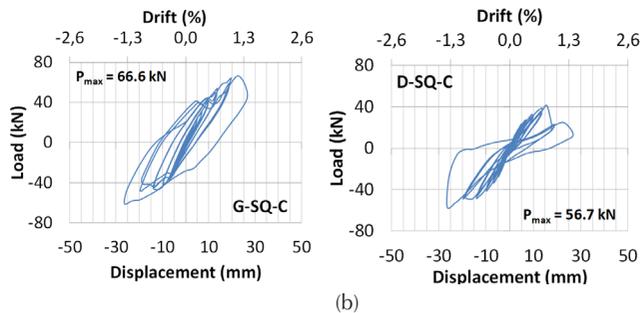
**Figure 10.** Hysteretic responses of the walls: (a) Slender walls; (b) Squat walls.  
**Source:** Authors

The hysteretic responses of the walls under cyclic loading are shown in Figure 10. The envelopes of the curves for slender and squat walls are shown in Figure 11.

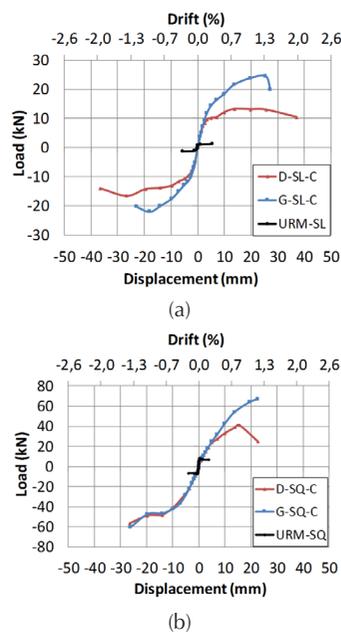
**Figure 11.** Envelopes of the hysteresis curves: (a) Slender walls; (b) Squat walls.  
**Source:** Authors

These envelopes show that slender and squat walls have a linear elastic behavior, until the drift reaches approximately 0,3%; except specimens G-SQ-C, which reached a value of 0,5%. From these values, the performance of the walls can be inelastic, with loading and unloading cycles that decrease the elements rigidity until the displacement reaches 2,0% in slender walls, and 1,3% in squat walls. Finally, the increase of important fissures and the degradation of rigidity decrease the loading capacity of the element.

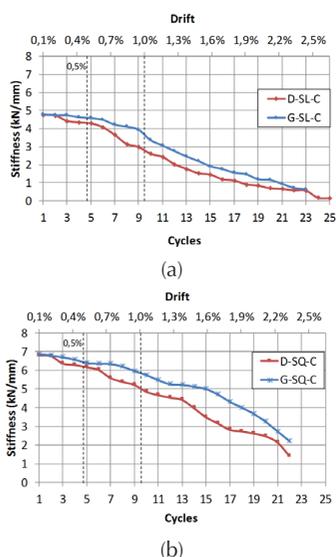
**Figure 12.** Degradation of the lateral stiffness: (a) Slender walls; (b) Squat walls.  
**Source:** Authors

The NSR-10 prescribes an allowable story drift of 0,5% for masonry cantilever shear walls, such as those tested in this research. Even if the failure mode is mainly flexural (like the foregoing), the story drift can reach 1,0%. Figure 12 illustrates the degradation of the lateral stiffness (secant stiffness) of the slender and squat walls, measured as the lateral load divided into the corresponding displacement in

every cycle of the tests. Table 4 summarizes the degradation of lateral stiffness for allowable drifts of 0,5% and 1,0%. As the loading and unloading cycles advance, the decrease of this property with a drift of 0,5% is low. In general terms, the walls with the “G” layout show less degradation of the lateral stiffness when compared to those strengthened with the “D” layout.

After the initial cracking of the slender walls, the ones strengthened with the ‘G’ layout showed stiffness degradation (measured relative to the initial lateral stiffness,  $K_0$ ) around 4% for an allowable drift of 0,5% and 23% for an allowable drift of 1,0%. The stiffness degradation was greater in the walls strengthened with the ‘D’ Layout, as it was of about 10% for an allowable drift of 0,5 % and around 41% for an allowable drift of 1,0%.

After the initial cracking of the squat walls, the ones strengthened with the ‘G’ Layout, showed stiffness degradation around 6% for an allowable drift of 0,5% and about 14% for an allowable drift of 1,0%. The degradation of stiffness was larger in the walls strengthened with the ‘D’ Layout: approximately 9% for an allowable drift of 0,5 % and around 25% for an allowable drift of 1,0%.

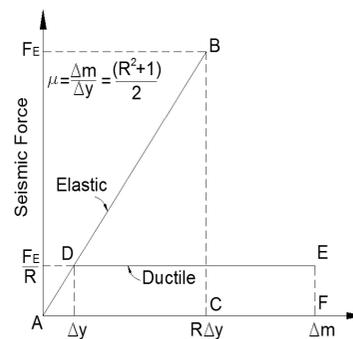
**Figure 13.** Relationship between ductility and force reduction factors -  $R$ .

In order to calculate the ductility and energy dissipation capacity in the inelastic range of the walls, the methodology described by Paulay & Priestley (1992) was used. Unreinforced masonry structures typically have short periods. For structures with short periods, ductility can be measured using the equal-energy principle. In this approach, the displacement ductility factor ( $\mu$ ) is estimated by equating the area under the inelastic force-deflection curve and the area under the elastic relationship, with equal initial stiffness, as shown in Figure 13. From this figure, the relationship between the displacement ductility factor and the force reduction factor ( $R$ ) can be expressed as. From this equation,  $R$  for short-period structures can be expressed as. The displacement ductility was computed as, where  $\Delta_m$  is the maximum displacement and  $\Delta_y$  is the displacement at yielding. The slender walls show higher ductility values than the squat walls, in approximately 1,5 times, which was expected since slender walls are less stiff. Table 5 summarizes the displacement ductility factors ( $\mu$ ) and the force reduction factors ( $R$ ) calculated for the slender and squat walls. The  $R$  factors obtained for the slender and squat walls are approximately 3,6 and 2,8, respectively.
